# Special Protection Area Program Annual Report 2007

Prepared by the Montgomery County Department of Environmental Protection in Cooperation With the Department of Permitting Services and the Maryland-National Capital Park and Planning Commission

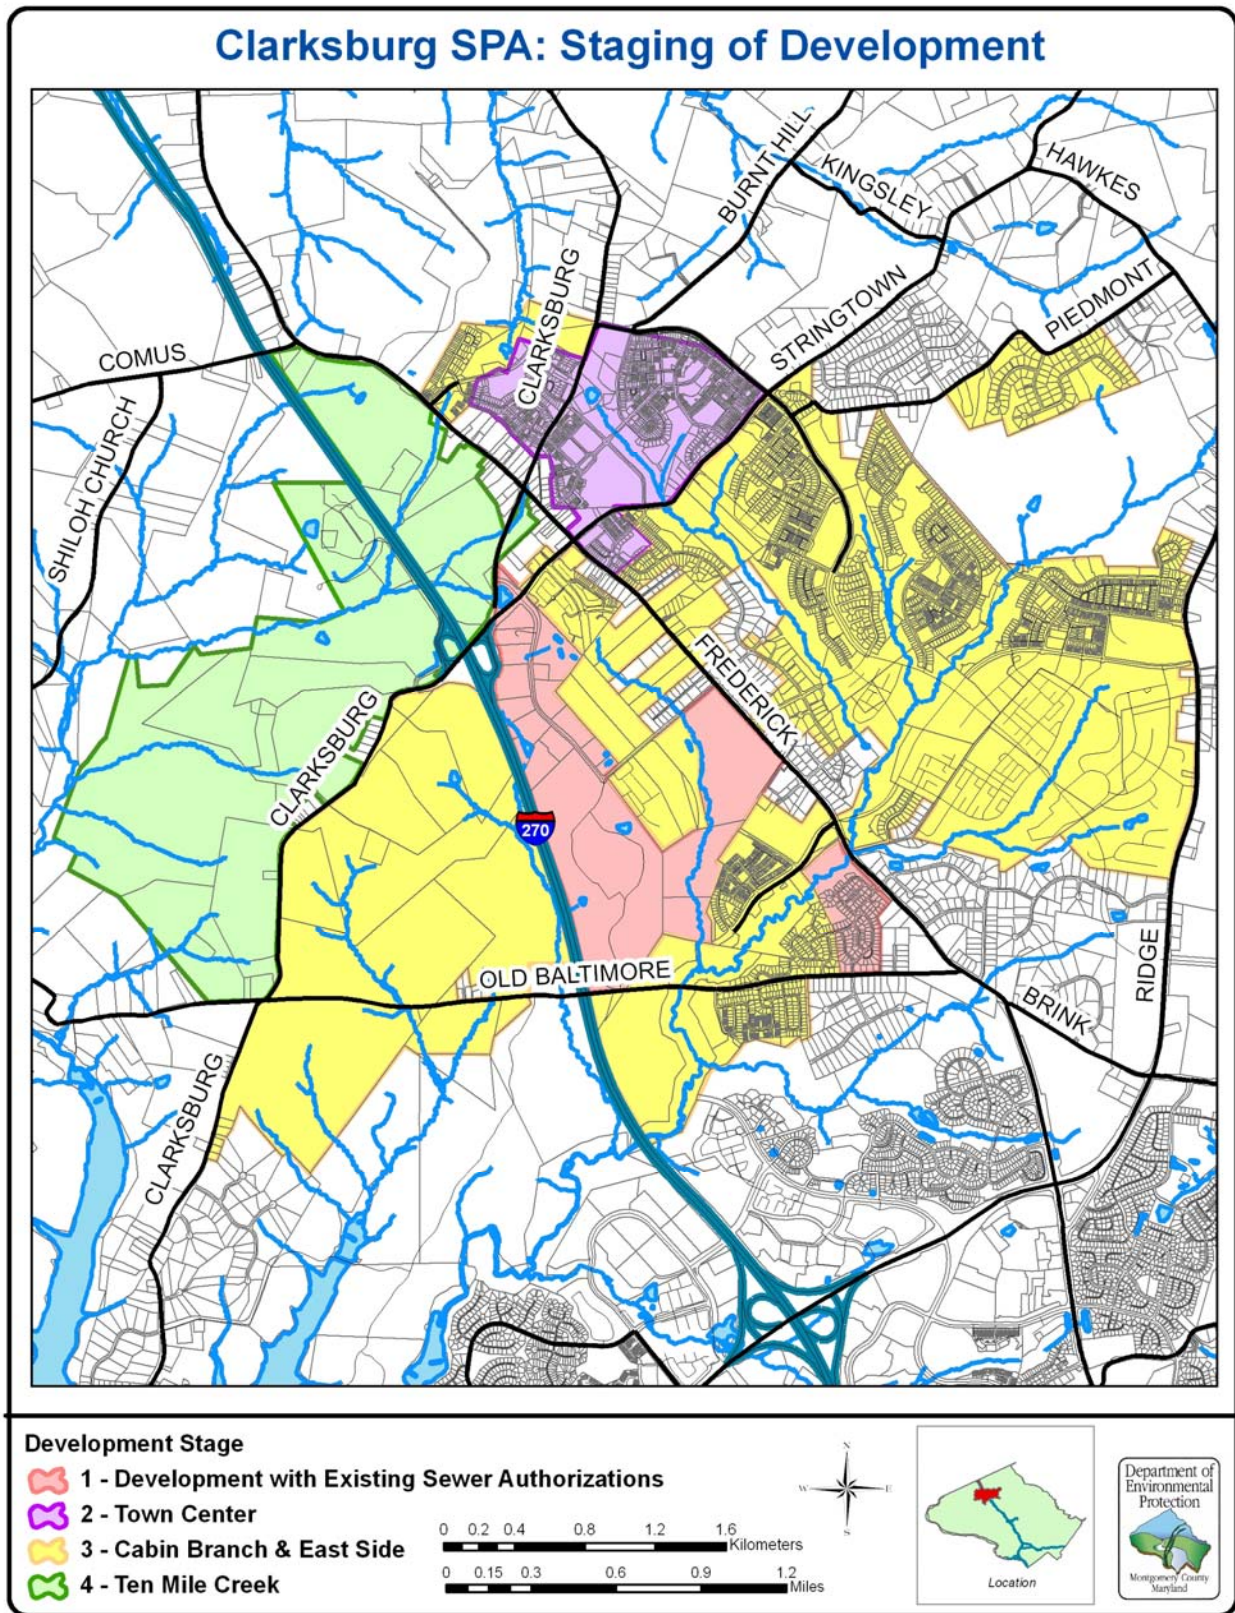
Figure 1.2. The Four Development Stages in the Clarksburg Master Plan Area.

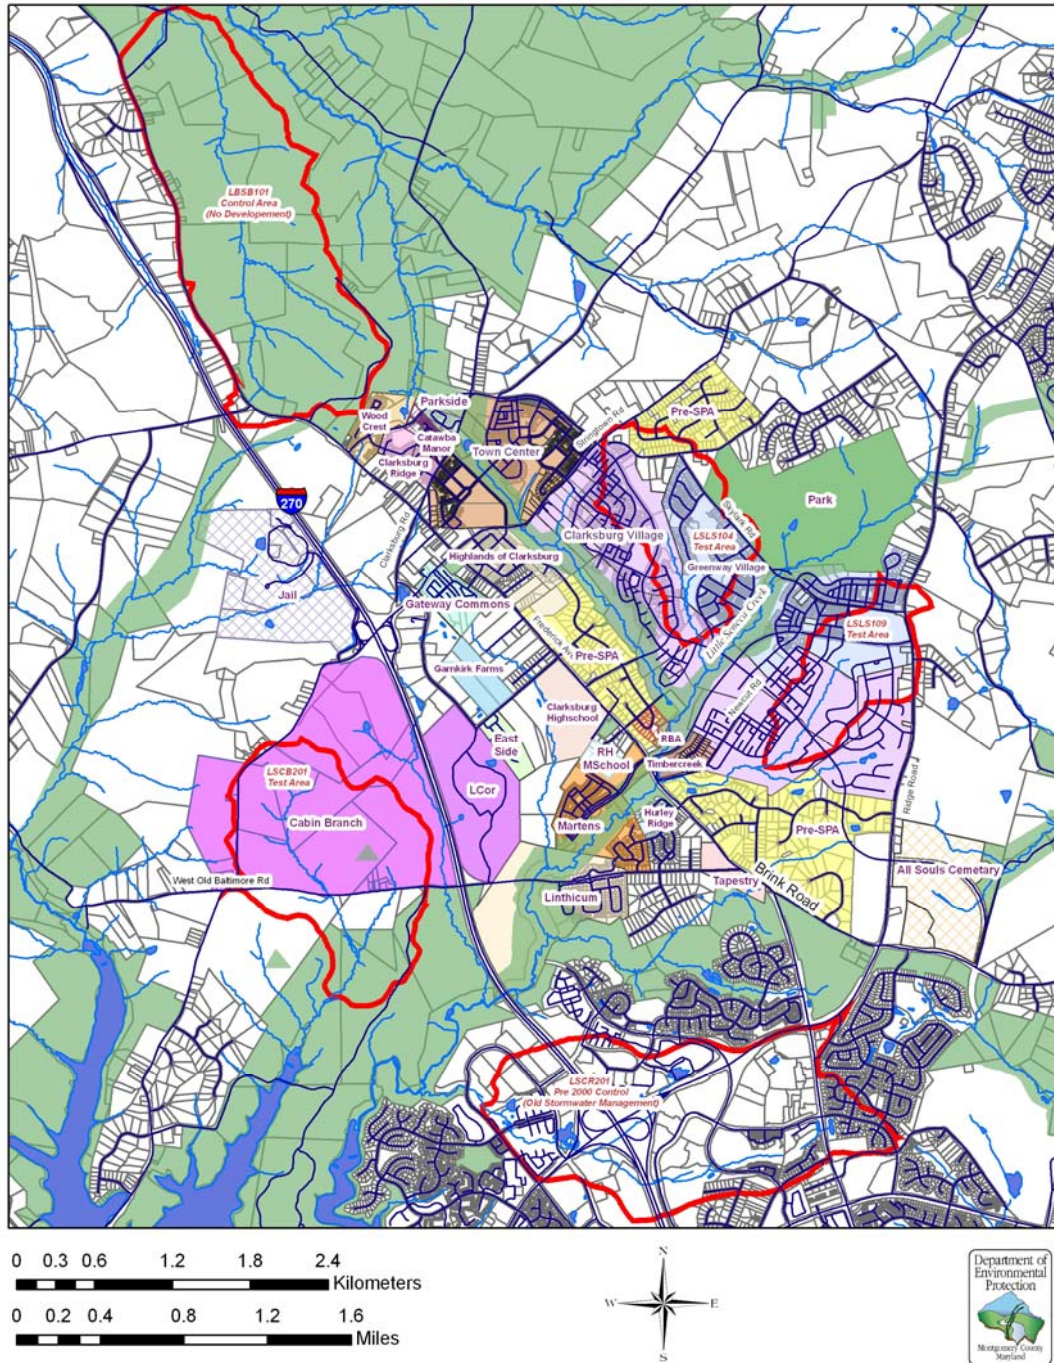
**Figure 1.3. Location of the Clarksburg Monitoring Partnership BACI Three Test Areas and Two Controls Areas.**

The CMP is using a *Before, After, Control, Impact (BACI) design* approach (Fig. 1.3) to assess the land use changes and the impacts to stream conditions. Three test areas were selected: two in the Newcut Road Neighborhood and one in the Cabin Branch Neighborhood (Fig. 1.3). An undeveloped control area was established in Little Bennett Regional Park and a final developed control area was set up in Germantown (Fig. 1.3). All the test areas have United States Geological Survey (USGS) flow gages installed and are collecting continuous stream flow data over time. Two rain gages monitor area rainfall and document local rainfall intensities to correlate rainfall intensity to stream flow characteristics. LiDAR (Section 4.1) imagery will assist in the mapping of landscape changes as a result of the landscape alterations in Clarksburg. Changes in hydrology and geomorphology will be linked to changes in the *benthic macroinvertebrate* and fish communities. Other private and public researchers are collecting information on changes to groundwater levels and quality. Changes to stream ecosystem structure and function are being done through advanced studies of community metabolism nutrient uptake and decomposition. This collaborative approach to monitoring long term change in an aquatic ecosystem has resulted in a comprehensive approach to document the effectiveness of land use planning and the use of modern S&EC and SWM BMPs.

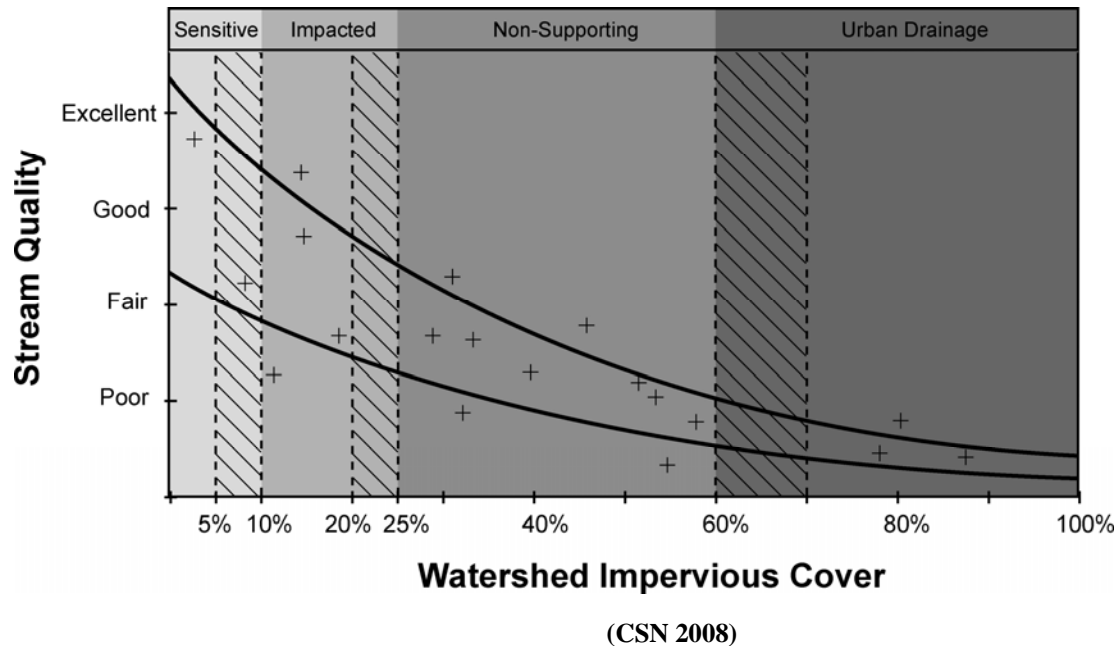
**Figure 1.4. The Reformulated Impervious Cover Model**

One of the most widely used predictors of the effects of imperviousness on water quality in streams is the Impervious Cover Model (ICM) (Fig. 1.4) created by the Center for Watershed Protection (CWP 2003) and updated by the Chesapeake Stormwater Network (CSN 2008). The ICM defines four categories of urban streams based on how much impervious cover exists in their subwatershed: *high quality streams*, *impacted streams*, *non-supporting streams*, and *urban drainage*. The ICM can be used to develop specific quantitative or narrative predictions for stream indicators within each stream category. These predictions define the severity of stream impacts with respect to changes in stream hydrology, alteration of the stream corridor, stream habitat degradation, declining water quality and loss of aquatic diversity.

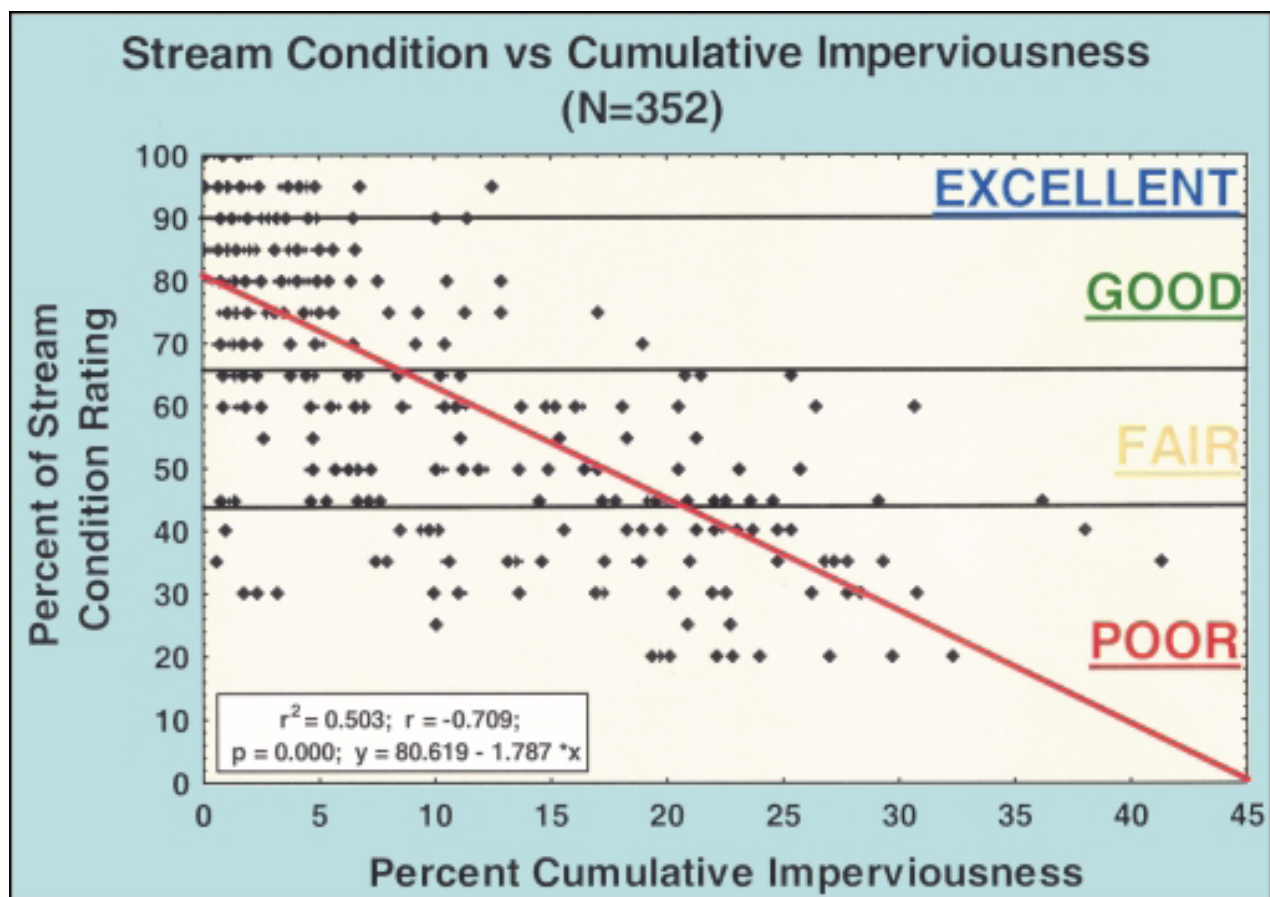
**Figure 1.5. Preliminary Relationship Between Imperviousness and Stream Condition Ratings in Montgomery County, MD (MCDEP 2003).**

The 2003 (MCDEP) update to the Countywide Stream Protection Strategy (CSPS) observed that impervious and highly compacted surfaces covering the landscape affect how much water infiltrates and how much runs off. A regression model developed by DEP, and based solely on available county stream quality and watershed impervious area data, predicts that aquatic insect IBIs (Section 5) decline to the *fair* category when imperviousness exceeds 8%. When imperviousness exceeds 21%, the model predicts that aquatic insect IBIs shift to the *poor* category (Fig. 1.5).

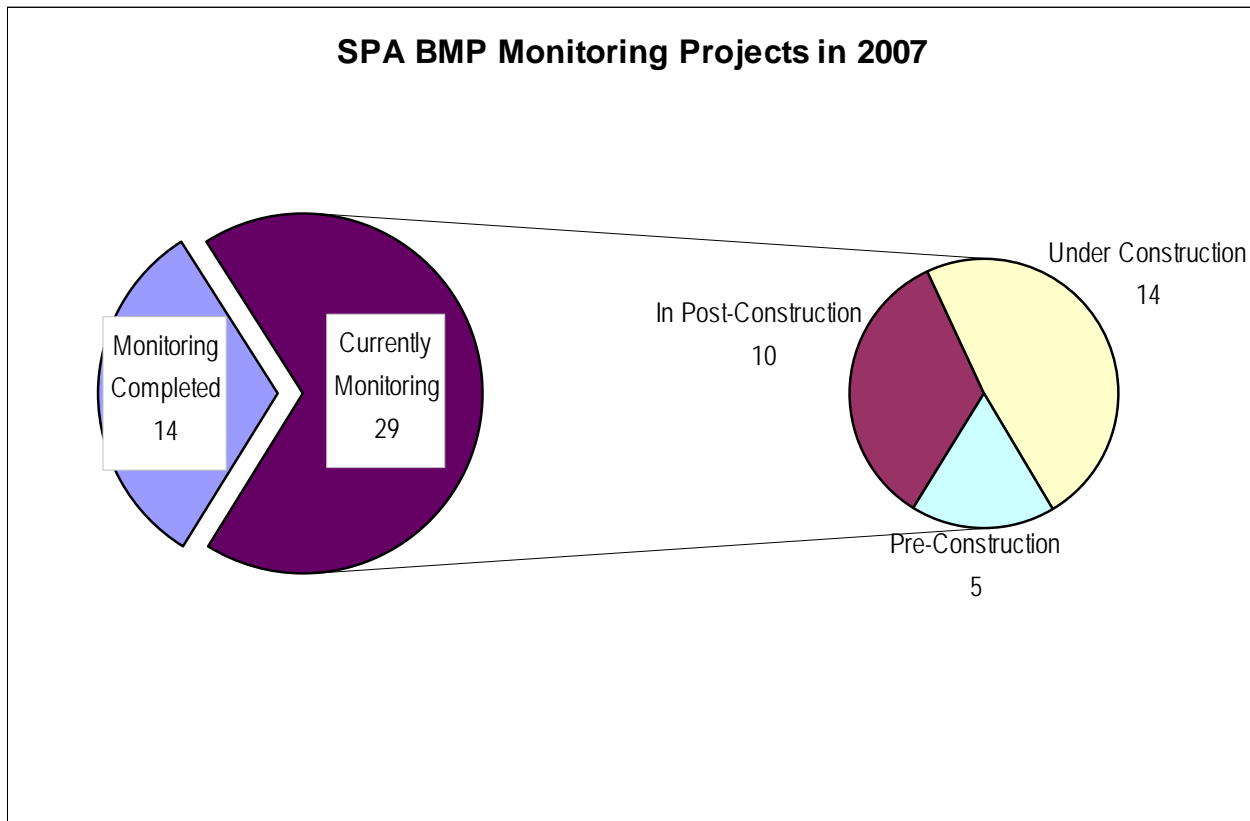
**Figure 3.2. SPA BMP Monitoring Project Status in 2007.**

four of which were monitoring BMP pollutant removal efficiency using automated sampling. The majority of projects remain in the construction phase. Fourteen projects are collecting data on construction conditions. Eleven of these projects are required to perform structural S&EC BMP efficiency monitoring. Five projects were conducting pre-construction (baseline) monitoring.

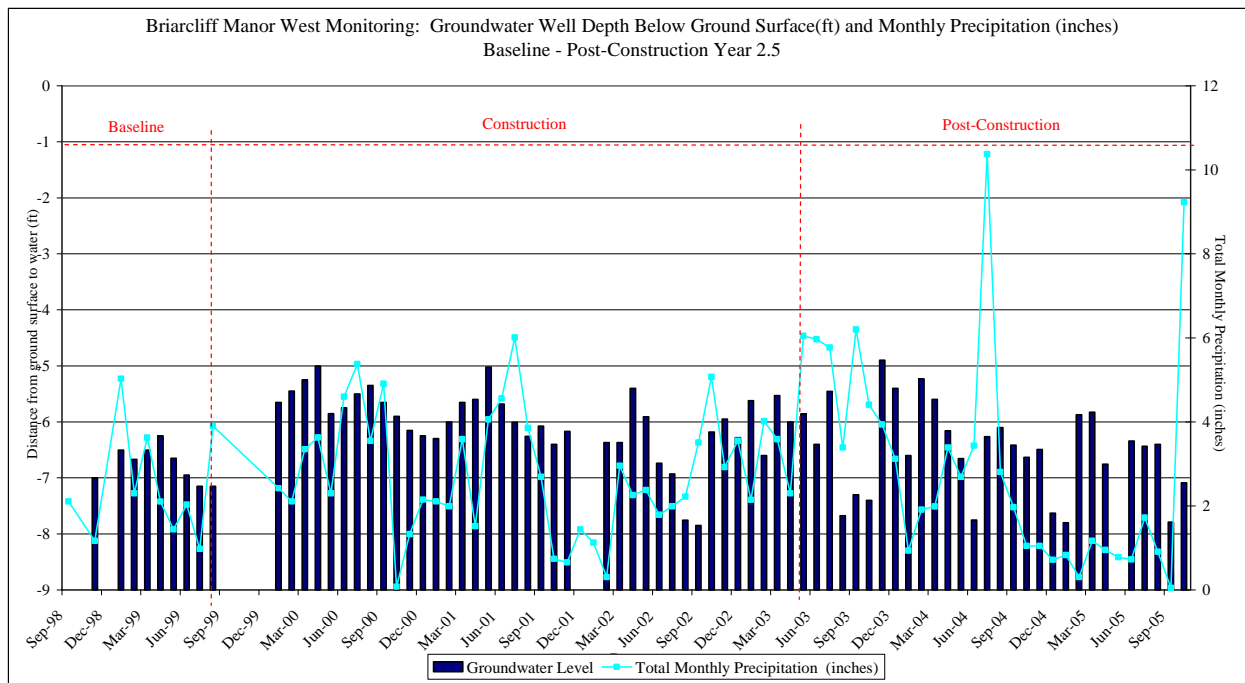
**Figure 3.3. Briarcliff Manor West (Upper Paint Branch SPA) Groundwater Monitoring.**

Groundwater chemistry was monitored at two of the completed projects, both of which produced inconclusive results. The name of the projects and the compounds monitored are located in the Technical Appendix. BMP monitoring of groundwater chemistry before and after construction at one well at the Clarksburg Detention Center (Clarksburg SPA) revealed nitrate levels above the EPA Drinking Standard of 10 mg/L. Levels ranged from 15.0 to 31.2 mg/L. During the late 1970's, a parcel of land near the well was used as a site for disposal of sewage sludge, which may explain the elevated levels.

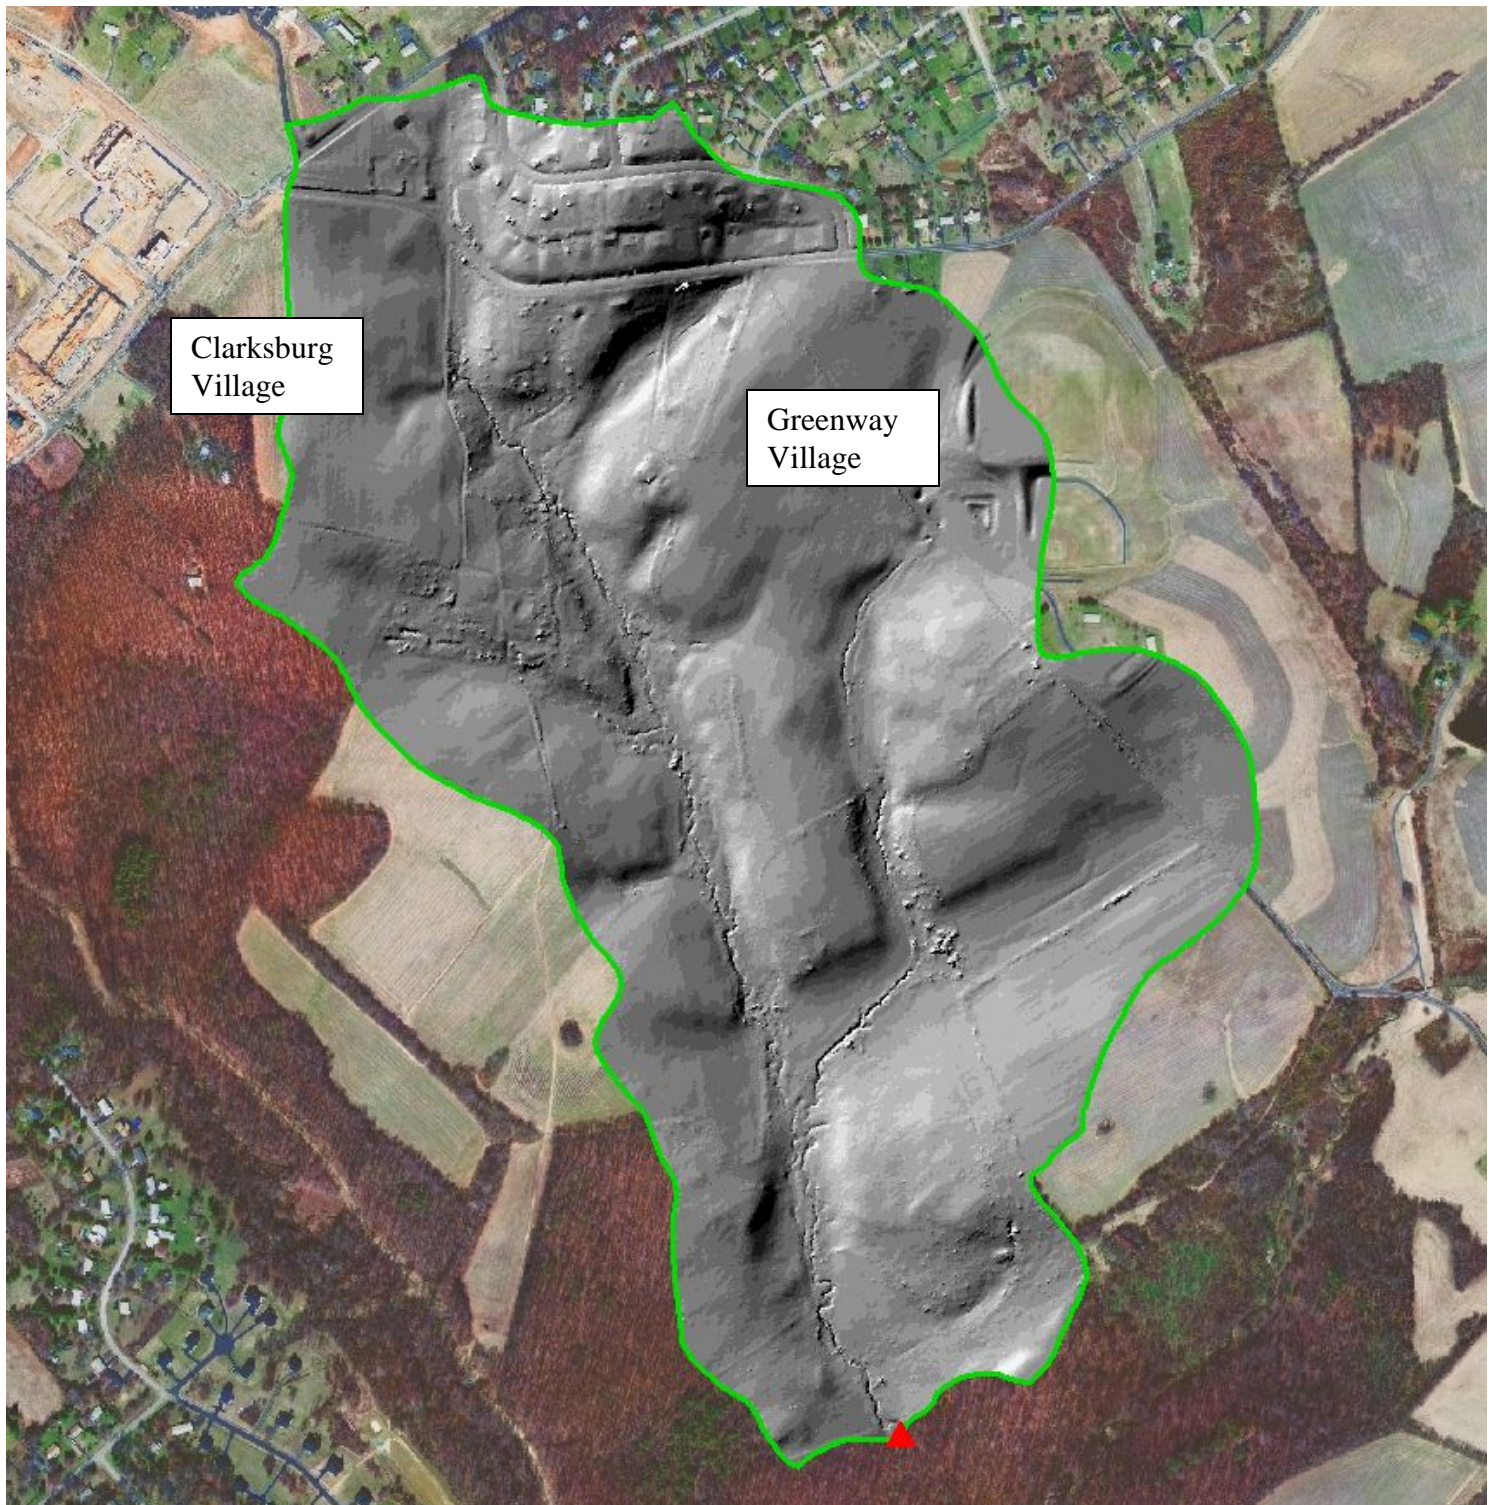
**Figure 4.1. 2002 LiDAR Imagery of Newcut Road Neighborhood, Greenway Village, and Clarksburg Village (U.S. EPA LEB).**

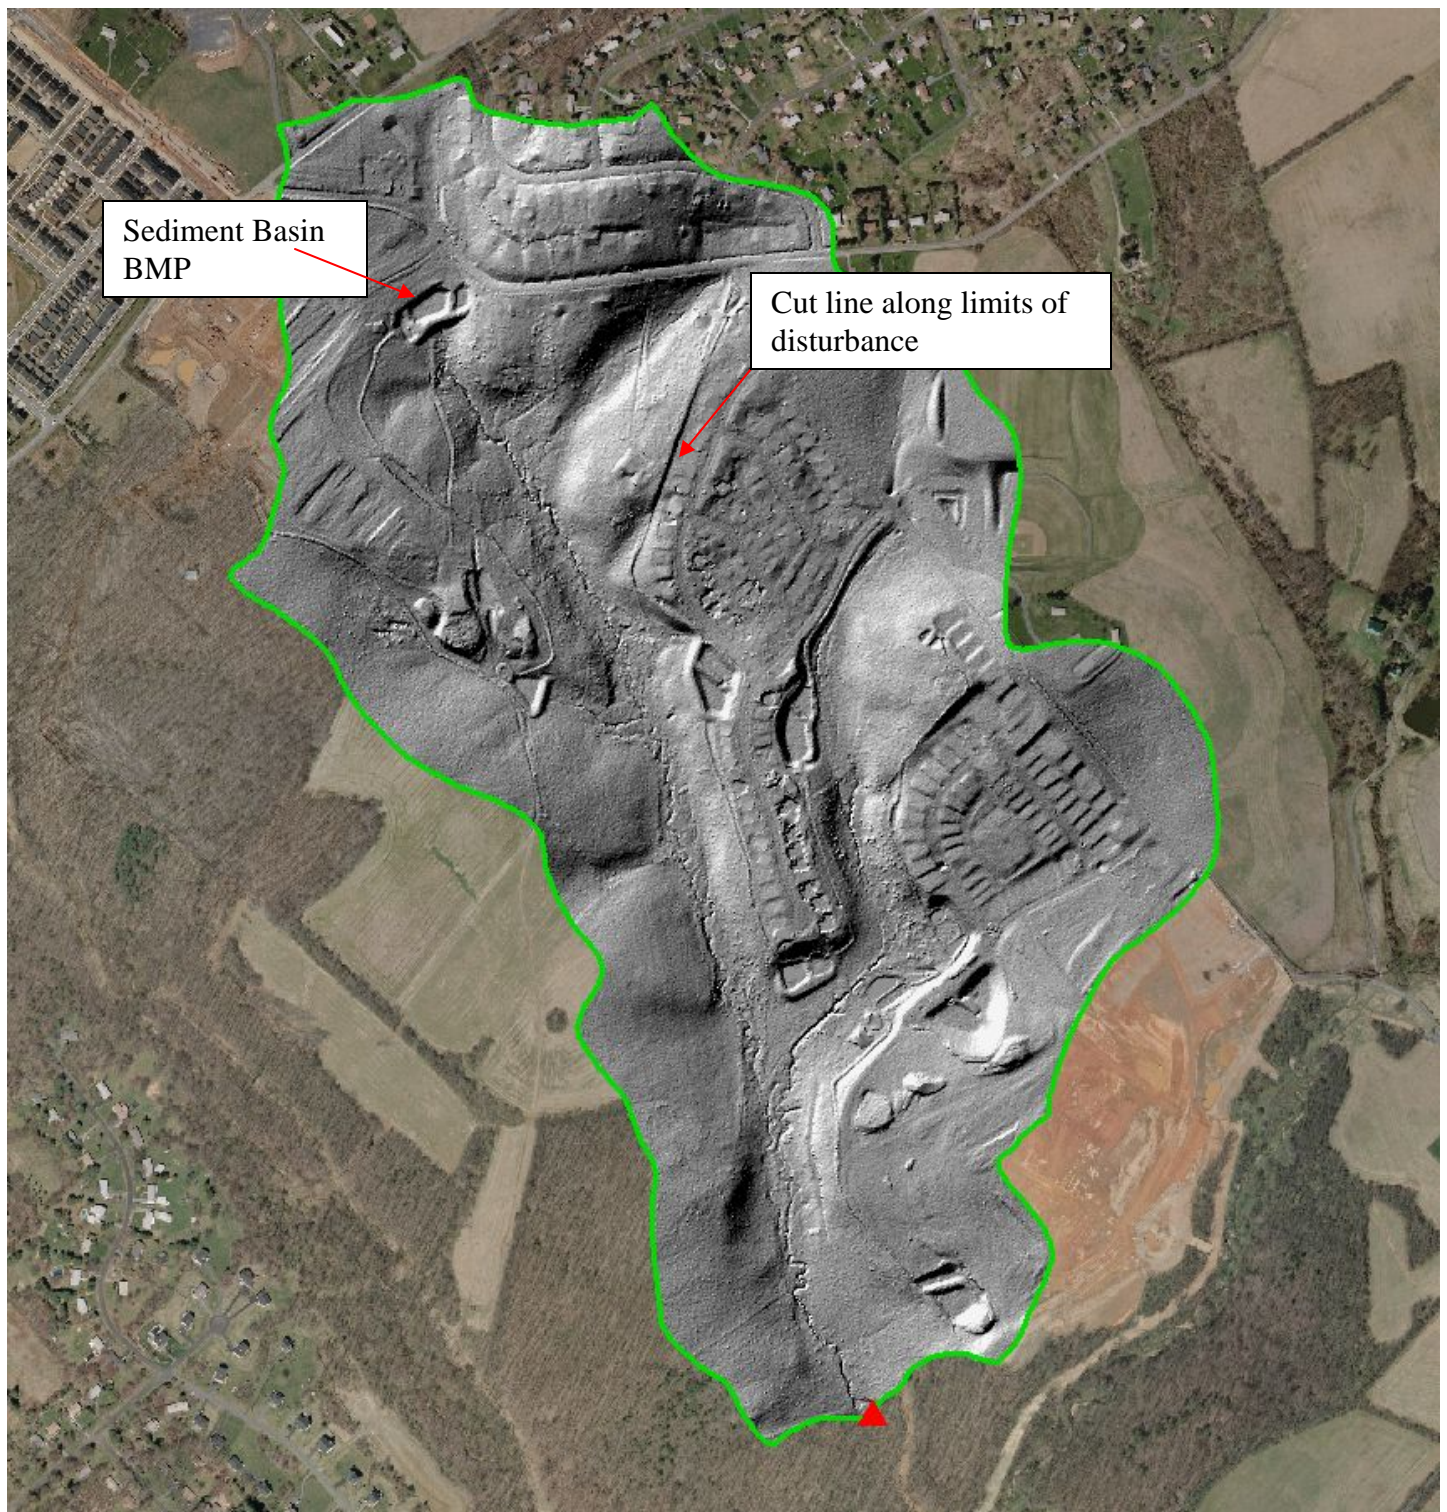
**Figure 4.2. 2004 LiDAR Imagery of Newcut Road Neighborhood, Greenway Village, and Clarksburg Village (U.S. EPA LEB).**

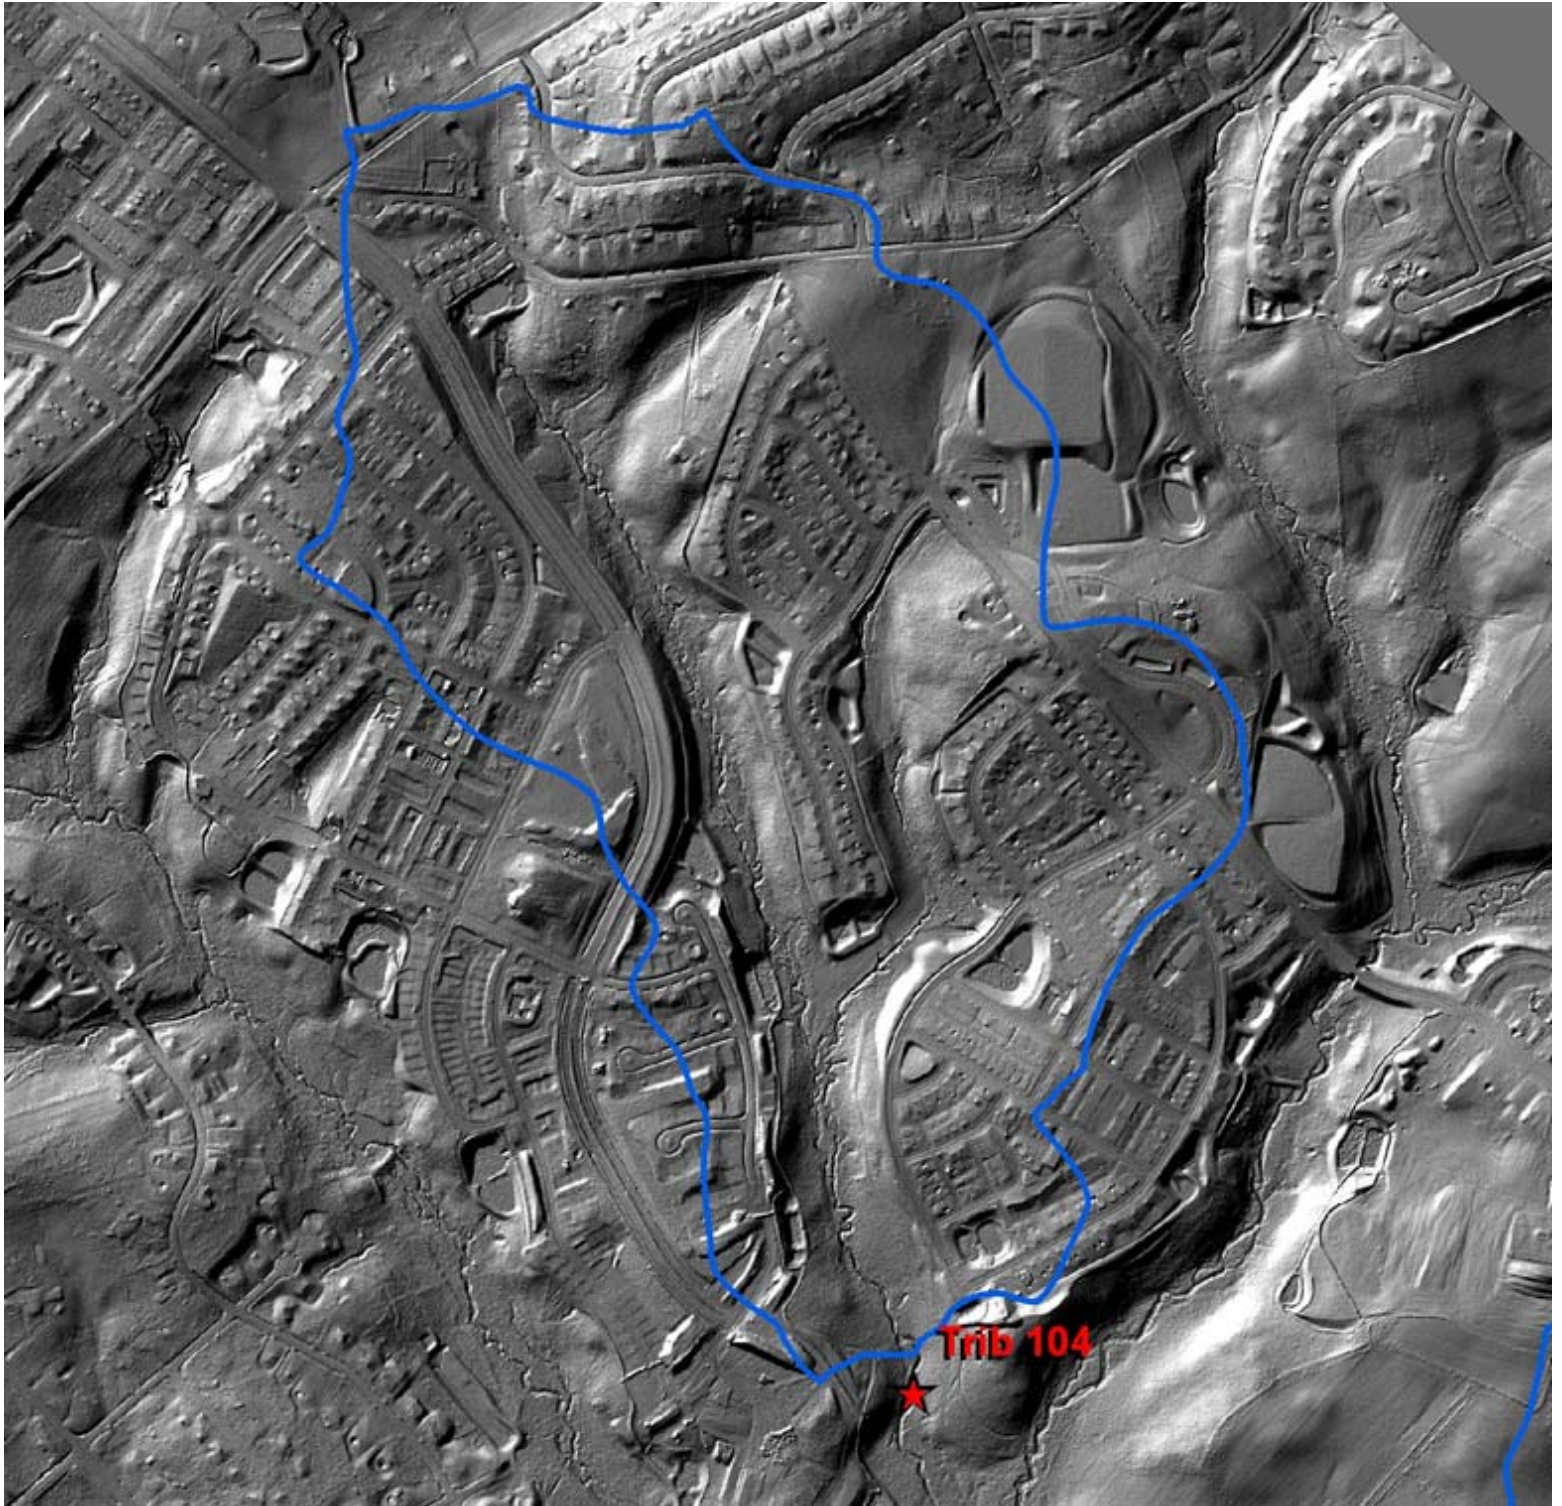
**Figure 4.3. 2007 LiDAR Imagery of Newcut Road Neighborhood, Greenway Village, and Clarksburg Village (U.S. EPA LEB).**

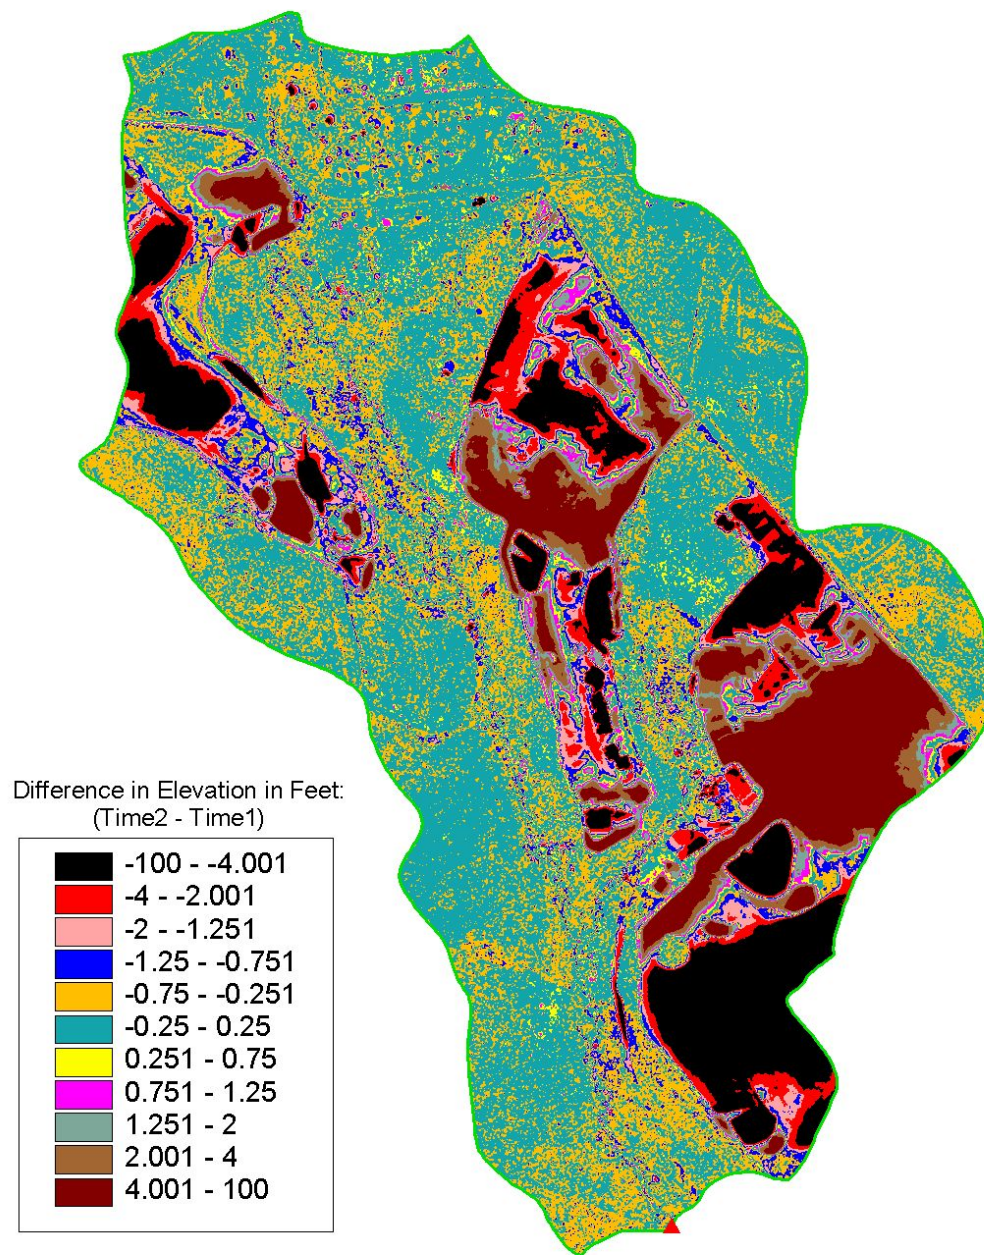
**Figure 4.4. Total Cut and Fill Differences for the Newcut Road Neighborhood, Greenway Village, and Clarksburg Village between years 2002 & 2007 (U.S. EPA LEB).**

neighborhood of Clarksburg through 2007 (See Section 4.1). The cut-and-fill approach to site development permanently alters the overall topography, natural drainage patterns, and natural infiltration conditions. These changes to the landscape alter hydrology and can permanently affect water quality.

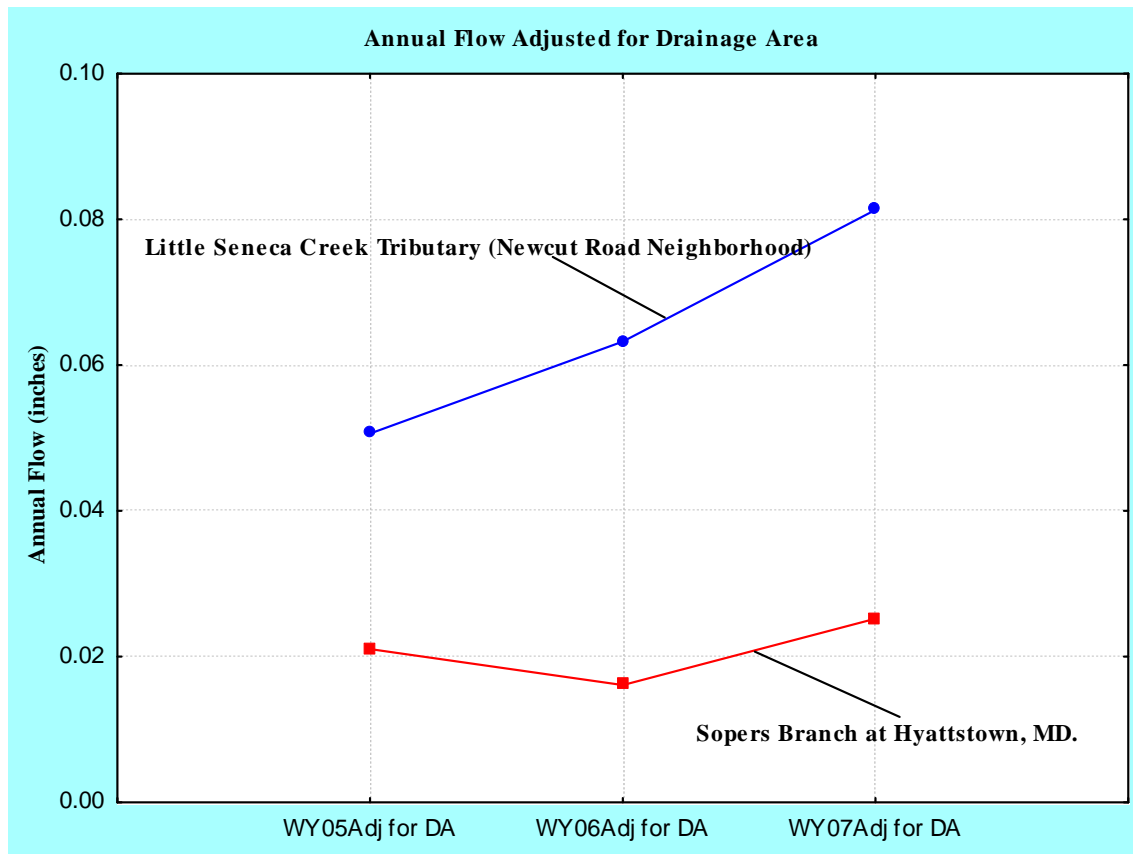
**Figure 4.5. Annual Flow (adjusted for drainage area).**

The overall amount of stormwater runoff directly entering the Newcut Road Neighborhood Tributary to Little Seneca Creek increased over this same time period. Annual flows were adjusted for the differing drainage areas of the two gages to normalize the annual runoff amounts and to allow for comparison. The adjusted annual flows are shown in Figure 4.5. More rainfall is running directly into the Newcut Road Neighborhood Tributary stream than Sopers Branch for the 2005, 2006, and 2007 water years (Fig. 4.5). This is likely due to the changes in imperviousness that have occurred in the drainage area as a result of development.

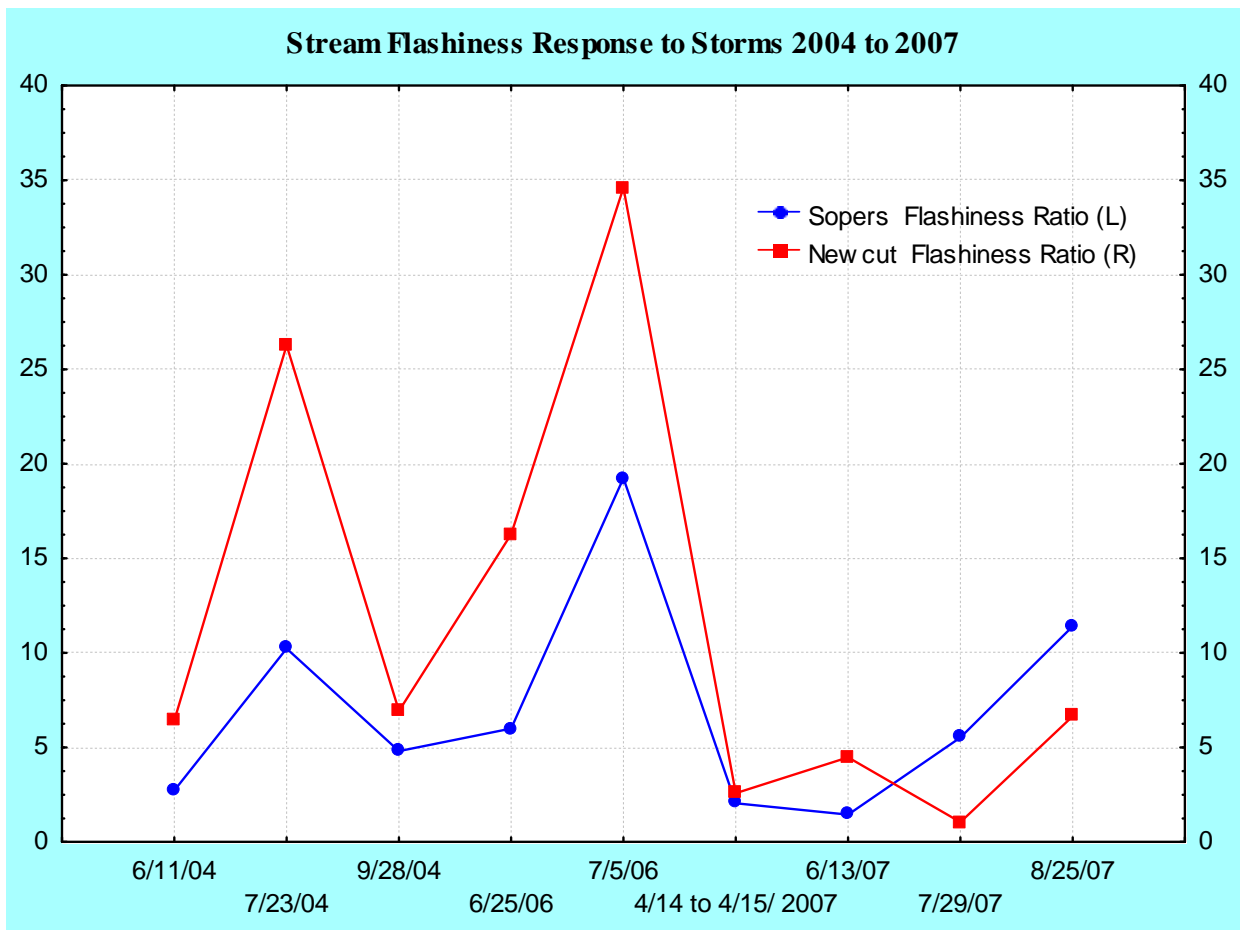
**Figure 4.6. Comparison of Stream Response to Storm Events: 2004 to 2007.**

the time of concentration of a watershed can be useful in understanding stream response to increases in imperviousness. When the conversion to SWM BMPs have been completed, time of concentration will be evaluated to determine if the Newcut Road tributary's response to rainfall has been changed compared to the control station. At this point in the development process, time of concentration is similar between the Sopers Branch and the Newcut Road Neighborhood (Tributary of Little Seneca) gages (Technical Appendix).

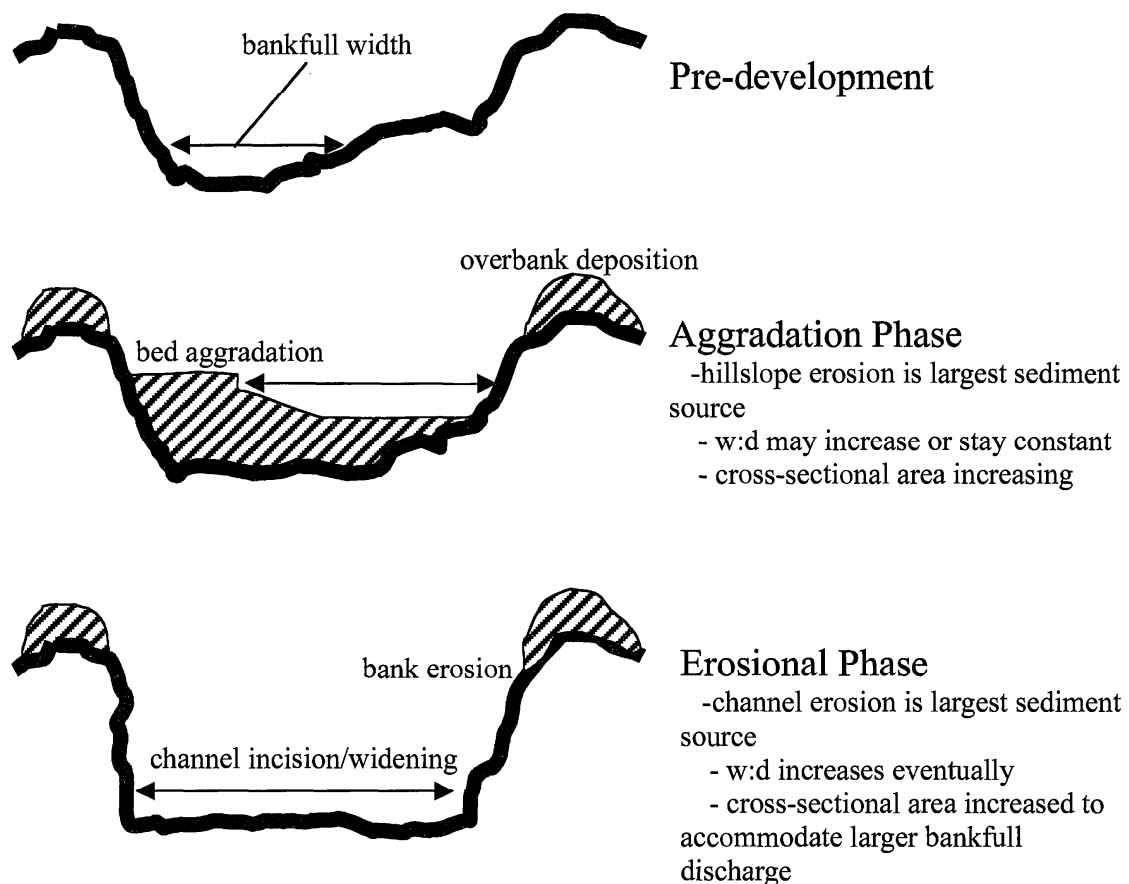
**Figure 4.7. Stream channel changes as a result of development and increases in imperviousness (Paul and Meyer 2001).**

Many studies have shown that impervious surfaces created as a result of urbanization are the primary cause of channel enlargement in suburban and urban areas. (Bledsoe 2001; Paul and Meyer 2001), (Fig. 4.7). The goal of the SPA SWM BMPs is to reduce storm flows to streams to predevelopment conditions. Streams are dynamic systems that adjust their geomorphology over time to the flows of sediment and water contributed by their watersheds (Bledsoe 2001). These adjustments are an effort to achieve a state of equilibrium as the morphology of a stream changes to compensate for increases and decreases in sediment loads.

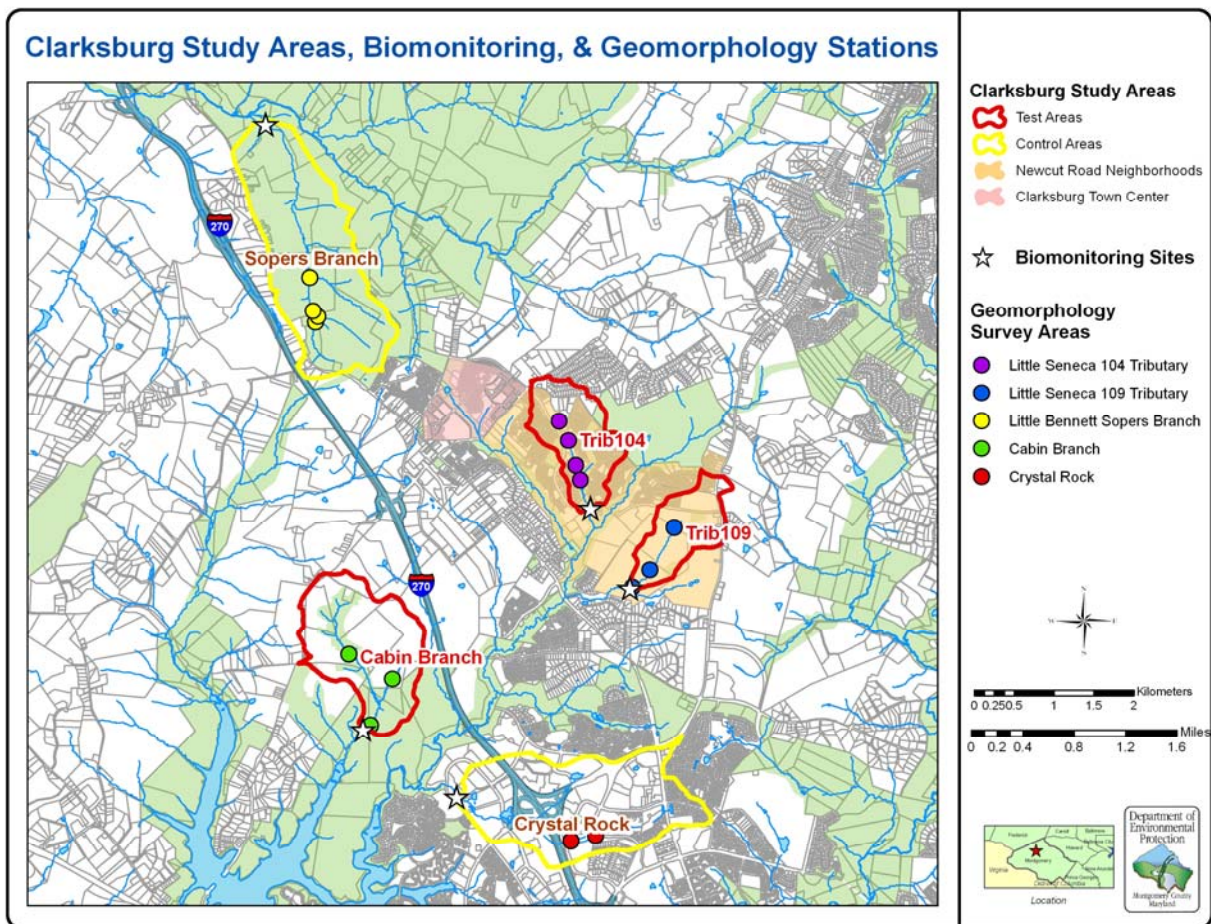
**Figure 4.8. Location of the Clarksburg Monitoring Partnership BACI three test areas and two control areas. Also included are biological monitoring stations and geomorphic survey locations.**
